Project Inspection Report

Sample Name : ADXL357BEZ-RL7

Manufacture : ADI

Report No:	SZ09062021001
Date:	2021/09/06
Page:	2/22

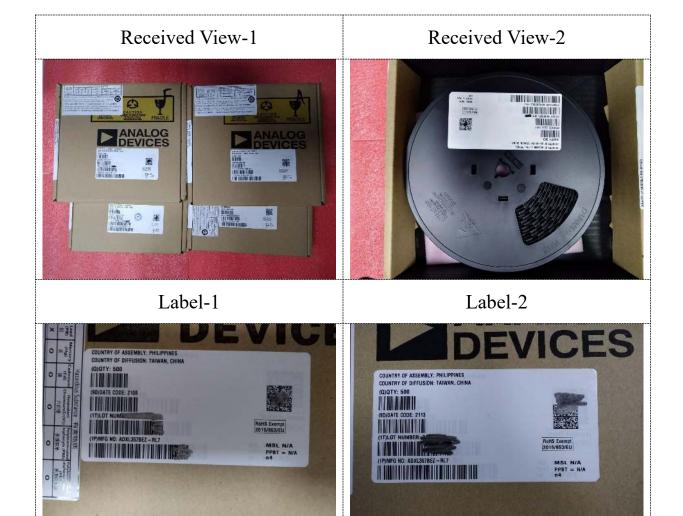
Gross Weight	1036 g	Parts Total	2500 PCS
Number Of Boxes	4	Full Label	Exist
Package type	Reel	Moisture protection	Non Present
MSL	N/A	ESD protection	Non Present

Test samples contain 41 PCS of D/C 2108(B1 to B41), 41 PCS of D/C 2106(C-1 to C-41) and 40 PCS of D/C 2113(D1 to D40).

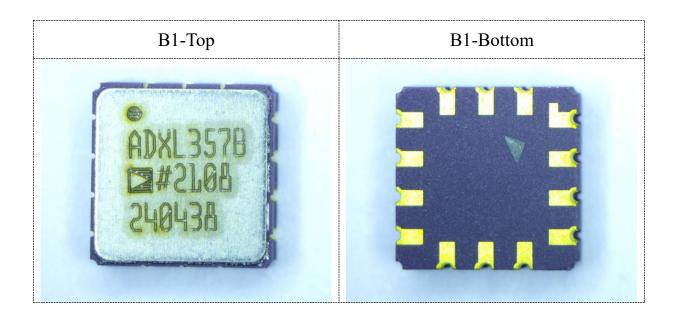
External Visual Inspection on 122 PCS(B1 to B41,C-1 to C-41,D1 to D40) samples. No secondary coating, sanding marks, crack or chips were observed on all inspected. Leads were in acceptable condition. Devices package and dimension matched to manufacturer's specification. All devices passed the external visual inspection.

L: 6.00 MM W: 6.02 MM H: 2.27 MM

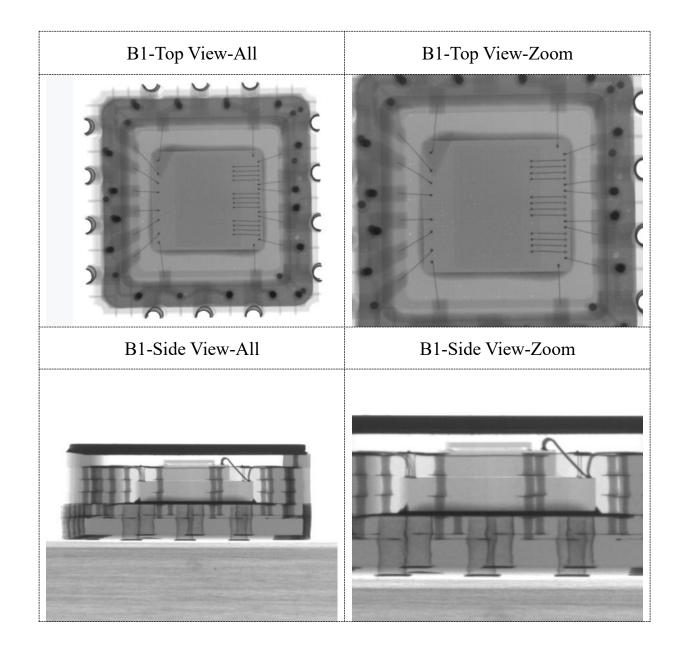
X-ray Inspection 49 PCS(B1 to B16,C-1 to C-16,D1toD17)samples. No structure or bonding wire abnormal was found.

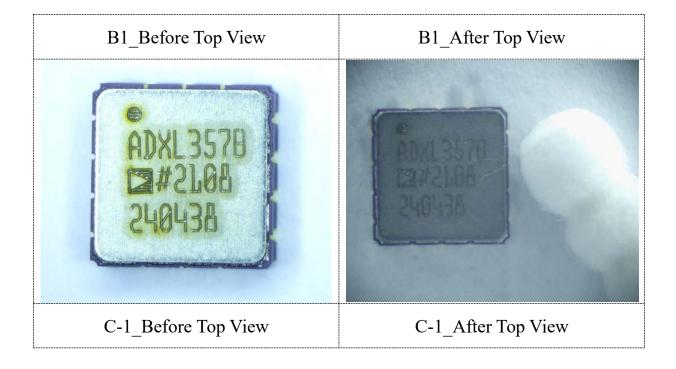
Heated Chemical Test were verified 3PCS (B1, C-1, D1) samples, all samples passed Heated Chemical Test.

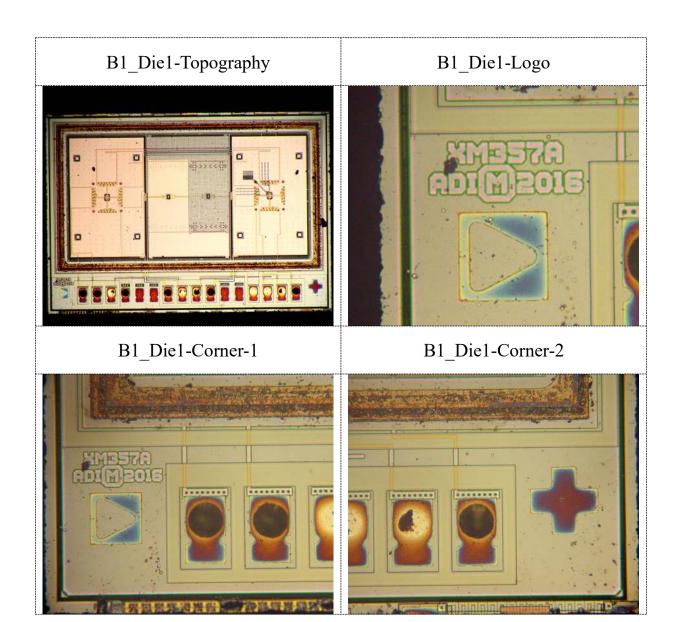
Internal Visual Inspection was verified on 3PCS (B1, C-1, D1) samples. 2 dies (Die1&Die2) were found.

Die1: Manufacturer ADI marking were found with 2016 copyright year. Die marking XM357A were found on the die surface.

Die2: Manufacturer ADI marking were found with 2015 copyright year. Die marking XL355 were found on the die surface.

Summary: All samples show the same structures and marking and samples confirmed to be a ADI device.
